Erfahrungsberichte

Steering by windvanes - Windpilot and Co -

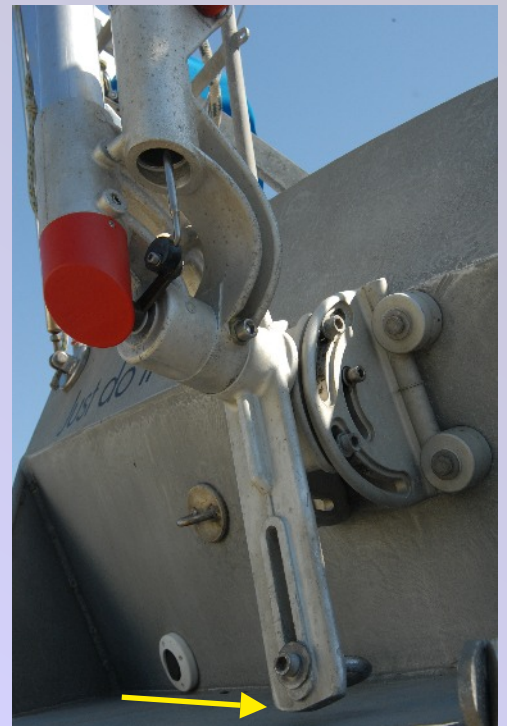
Despite the stern platform minimal fastening effort was required. We needed the manufacturer's base mount, nothing else. The original round-ended pendulum arm was shortened by the author near the ring bolt using an angle grinder (arrow), as it did not quite fit with the rear platform.

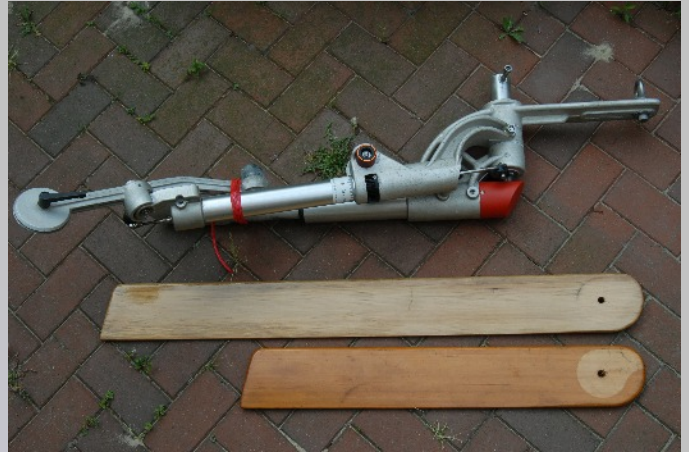
The system, completely overhauled after more than eight years of use. The compact design of the Windpilot Pacific is clearly evident. Different lengths of the pendulum rudder blades: above, the 110 cm long blade; below, the 80 cm long original version.

The difference not only means more power due to the longer lever arm, but also that when the longer pendulum rudder swings to windward, it is much deeper in the water. When heeling - our old boat was rank - the original rudder almost mounted on JUST DO IT nearly was lifted out of the water and was therefore unable to develop much power at these moments. Today, the manufacturer's pendulum rudder blades are also made of aluminum.

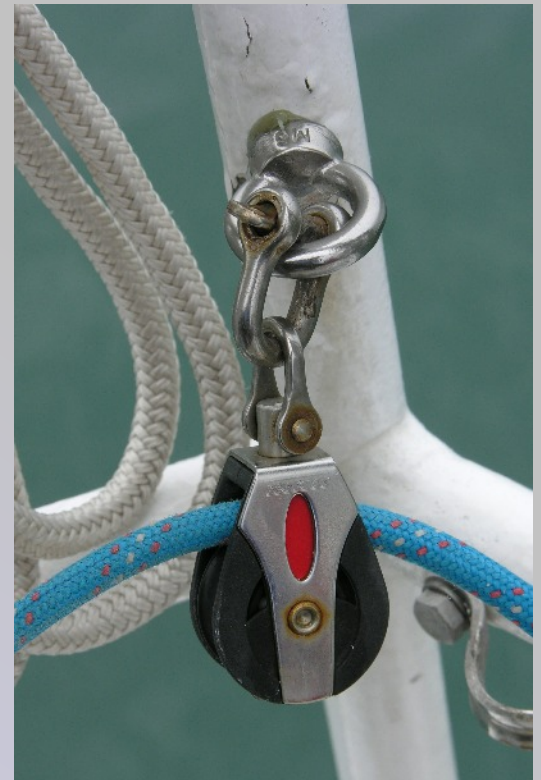
To reduce friction losses, we replaced all pulleys to pulleys with ball bearings. This shown is already the second generation; the first was blown apart at some point by the forces involved. Fastened using an eye bolt screwed into the solid aluminum railing. The threads held, but the stainless steel did not. After the first bolt sheared off, we inserted them and secured them with a nut. It is also easy to see that the paintwork on the railing is suffering because the paint layers were opened up by the drilling. The skipper did not seal them sufficiently against water ingress. Later, we also used lashings made of thin, multi-wound, dyneema line.

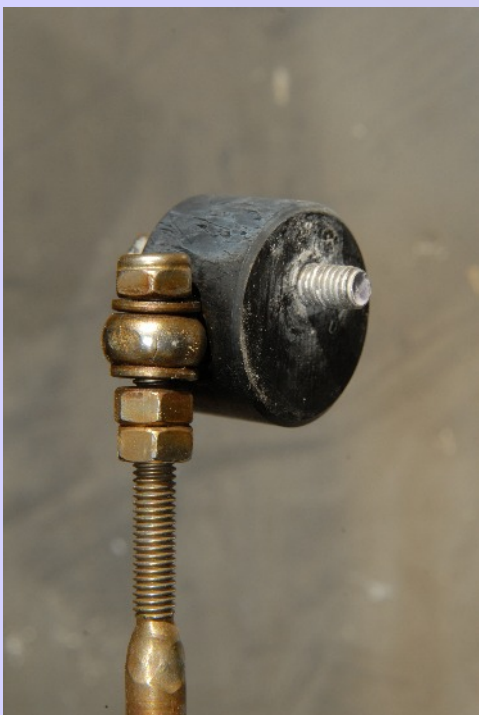
We noticed another detail that we had overlooked. The push rod between the wind vane and the pendulum rudder was bent. Was that supposed to be the case? Of course not. The cause: we had eliminated the necessary play at the upper mount of the push rod by tightening the screws. A small mistake with a big effect: the system cannot transmit the pendulum impulse in this way, and the push rod even jams.

A common source of problems with Windpilot Pacific and Pacific Plus: the upper mount of the push rod between the wind vane and the pendulum rudder! It is essential to leave some play between the self-locking nut at the top and the two lock nuts at the bottom. Without play, the push rod will jam and bend. The black POM washer must also remain movable. The bolt must therefore not be screwed in as far as it will go. Despite visible light aluminum oxide deposits the bolt could be unscrewed effortlessly.

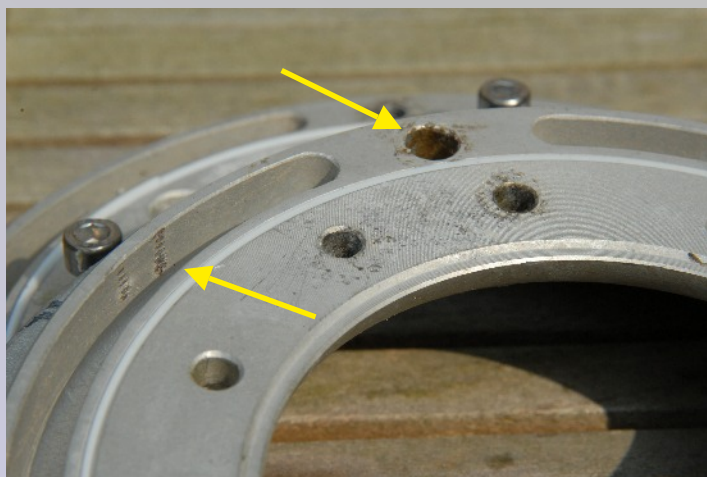
However the wheel adapter proved to be the weak link in our transmission chain. At first it was our fault, or rather mine: I had simply assembled it incorrectly, i.e. out of alignment. The threads of the clamping screws did not engage with the corresponding threaded holes, but with the grooves next to them. The screws clamped sufficiently there to give us a smooth crossing to the Canary Islands in calm conditions, but with six to seven Beaufort winds on the way to Cape Verde that was the end. Not the ideal time to notice something like that. Oh well, we heaved to and an hour later the issue was resolved. Uncle Henry, as we had christened the system in the meantime now steered without any problems.

How embarrassing! The skipper was careless when assembling the wheel adapter. Instead of engaging with the threaded holes (arrow above), the clamping screws engaged with the groove (arrow below). This won't work. The marks in the long groove near the arrow can be seen. Instead, the screw should have engaged in the larger hole near the upper screw.

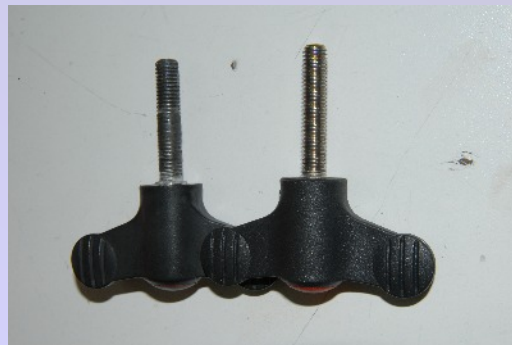
We were amazed that the clamping screws had withstood our brutal handling over all these years. A comparison with brand-new clamping screws revealed the beginnings of weakening: the steel shafts are slowly pulling out of the plastic.

Clamping screws or handles, old and new. Noticeable: the protruding steel pin of the old screw (left).

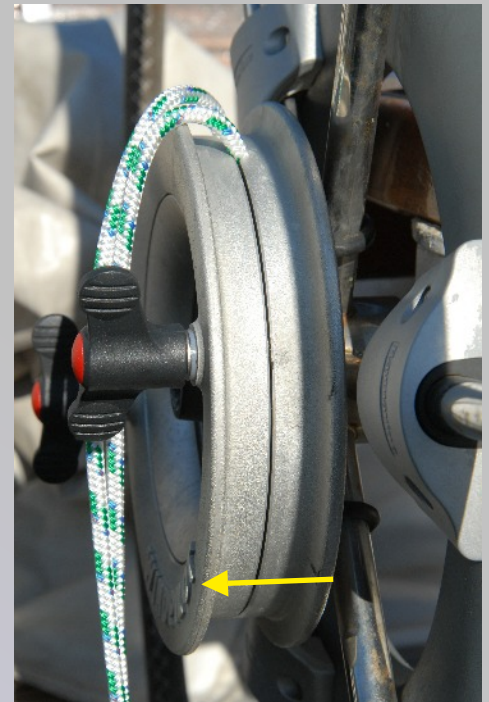
When correctly mounted, the gap between the two halves of the adapter must be loosely tightened to show an equal width. We noted the desired position of the adapter with the help of one of the elevated letters, at the lower part of the image (arrow), in relation to a spoke of the steering wheel.

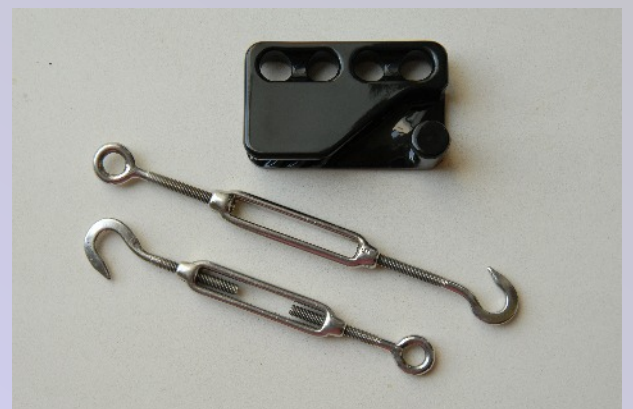
Below are the tensioning screws we used to adjust the line tension. The manufacturer later recommended a fender clamp (above) as the best way to reduce line play. He said that one is enough, regardless of which of the two pull lines it is used on. We suggest our solution as the easiest way.

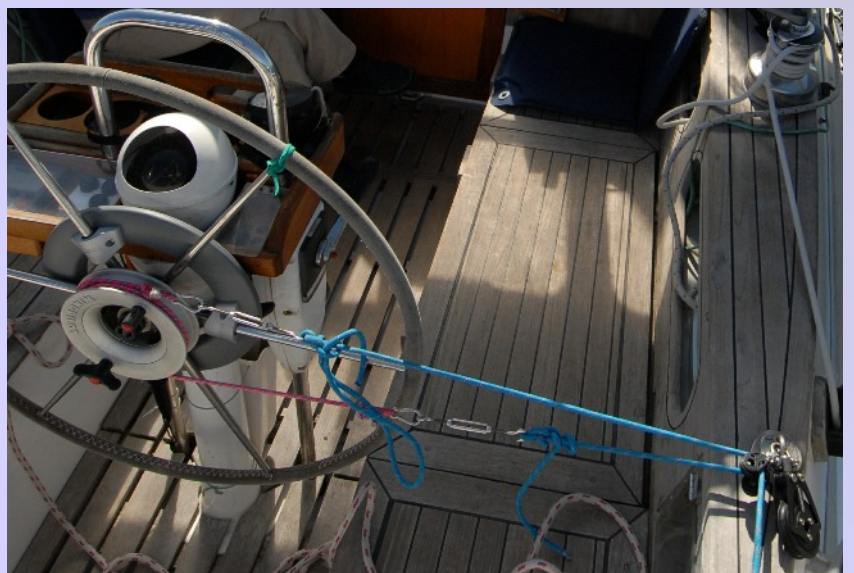
The tension screws in use. The pre-trim of the main rudder was finely adjusted by turning both tension screws four turns for example loosening one and tightening the other. The wheel adapter remained in the position previously fixed with the clamping screws. At the same time the tensioning screws helped to remove the last bit of slack from the steering lines (in this case, tightening both screws). We had made the blue lines very long so that we could shorten them from time to time and move the chafing points.

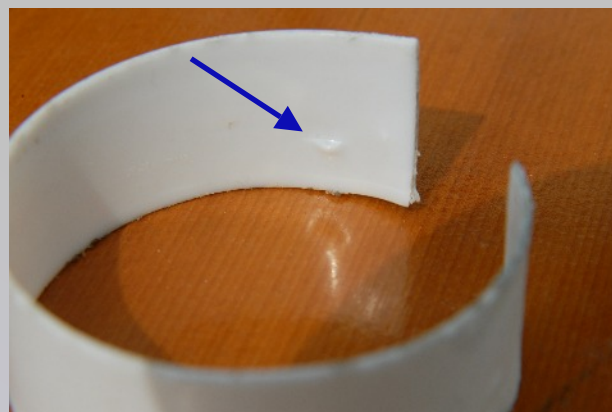
All components of the system could also be separated without any problems. Only the stiff and ultimately blocked hollow wind vane shaft, which is used to adjust the wind vane, could not be removed at first. The cause: salt and a small metal chip had found their way under one of the Delrin bearing strips, where they had corroded, bulged the strip and blocked the bearing. No wonder the shaft was stuck.

Extended bearing strip of the wind vane shaft. Small indentation, big impact: this barely visible indentation in the Delrin strip and the material behind it secure the wind vane shaft.

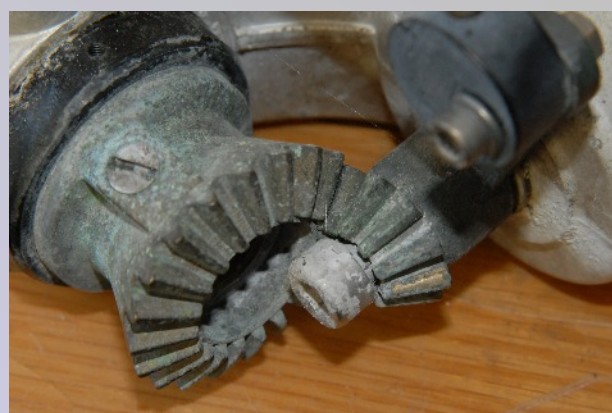
The bronze conical gears which had become very dirty due to a lack of maintenance over the past year and the POM parts of the system showed no signs of wear!

Here is the heavily soiled bevel gear just before dismantling. We had lost the cover and didn't pay much attention to the system in the first year after sailing around the world. After thorough cleaning, the bronze parts showed virtually no wear!

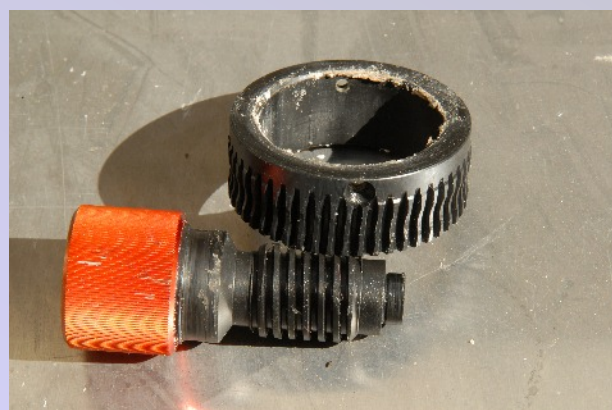
The adjusting screw and adjusting wheel for the wind vane immediately after removal. Somewhat dirty, but no noticeable wear on the worm gear.

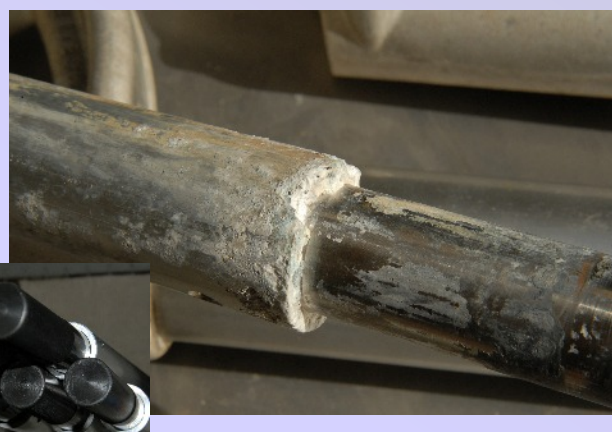
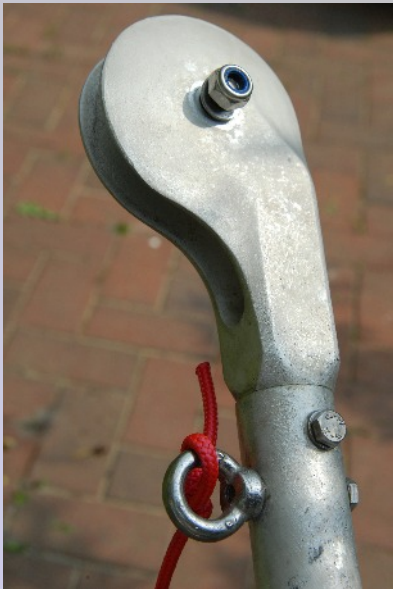
The thru-axle of the pendulum rudder mount had already loosened during the trip. We secured it by wrapping tape around the axle and sliding it into the shaft without any play. What we didn't realize was that the retaining bolt secures the axle with a thread cut into the thru-axle. You turn the bolt (carefully) and that's it. The bolt protrudes through the thru-axle and shaft and also serves as a mount for the safety line eye. This should only be turned on slightly. If you slam the eye because you want to "lock the bolt," you will tear out the thread of the thru-axle and the thru-axle will rattle.

This eye for the safety line must not be tightened too much, otherwise you will strip the thread of the thru axle of the pendulum rudder mount held in the tube. So only turn the eye by hand onto the thread coated with wool grease. The wool grease is sufficient to prevent loss. After the ignorant author had successfully destroyed the thread, a solid solution was found: the thru axle was secured with an additional bolt (top).

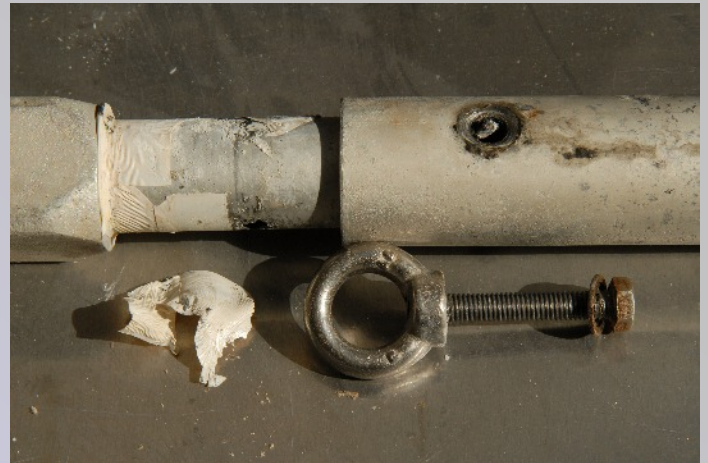
The pendulum rudder shaft was still freely movable and only needed to be cleaned. There was quite a lot of salt and aluminum oxide residue inside, but this did not impair its function. The source of the residue was found at the transition from the pendulum rudder shaft (aluminum tube) to the conical gear axle (stainless steel). There was severe oxidation here, a consequence of the material pairing. However the extent of the damage was (still) insignificant and did not impair the functionality of the system for the time being. Today, the manufacturer produces the conical gear shaft from POM. This should solve the corrosion problem.

Thru-axle of the pendulum rudder mount and shaft during disassembly. Salt and oxide encrustations, corrosion marks. However, not to a critical extent so far. It should be noted that this part of the system spent most of its time in the water during voyages. The taper marks are clearly visible. We used insulating tape to eliminate the play of the shaft in the mount (tube).

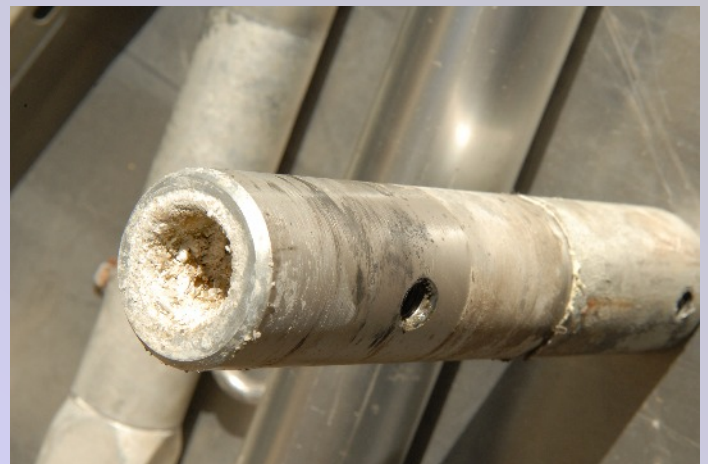
There was a significant amount of Delrin abrasion in front of the pendulum rudder's pivot axis, which also supports the entire wind steering system, but no salt. There is a sufficiently large cavity there to collect dirt and abrasion. The abrasion never affected the system. However, occasional inspection and cleaning is recommended.

The axle that secures the entire wind steering system in the bracket and around which the pendulum rudder swings. Condition immediately after removal: mainly dirty. A large amount of Delrin abrasion and a small amount of salt crystals were found in the pocket bore. Despite the residues, the pendulum rudder's thrust washers and bearing strips were fully functional.
